LANCASHIRE COUNTY FIRE BRIGADE

ACCIDENT INVESTIGATION REPORT

TALBOT SHOWROOMS  
440 TALBOT ROAD  
BLACKPOOL

5 MAY 1990

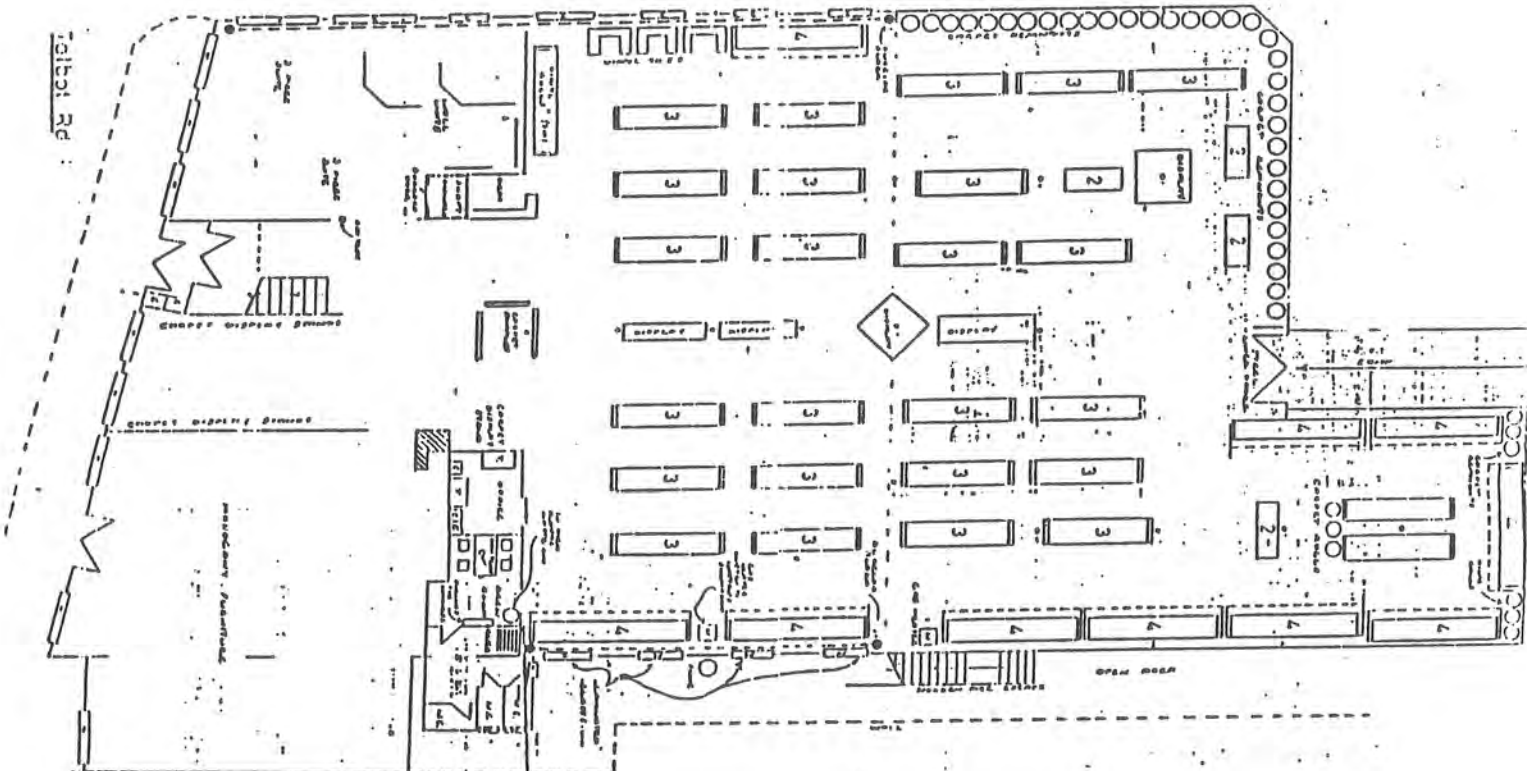
GROUND FLOOR

- 4: ROLLS 2m. 15cm. high  
Base roll just off floor.  
Top of base roll approximately  
1m. from floor.
- 3: ROLLS 1m. 53cm. high
- 2: ROLLS 91 cm. high

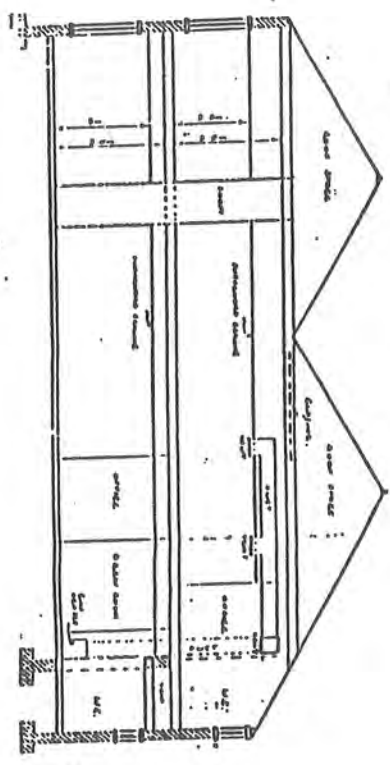
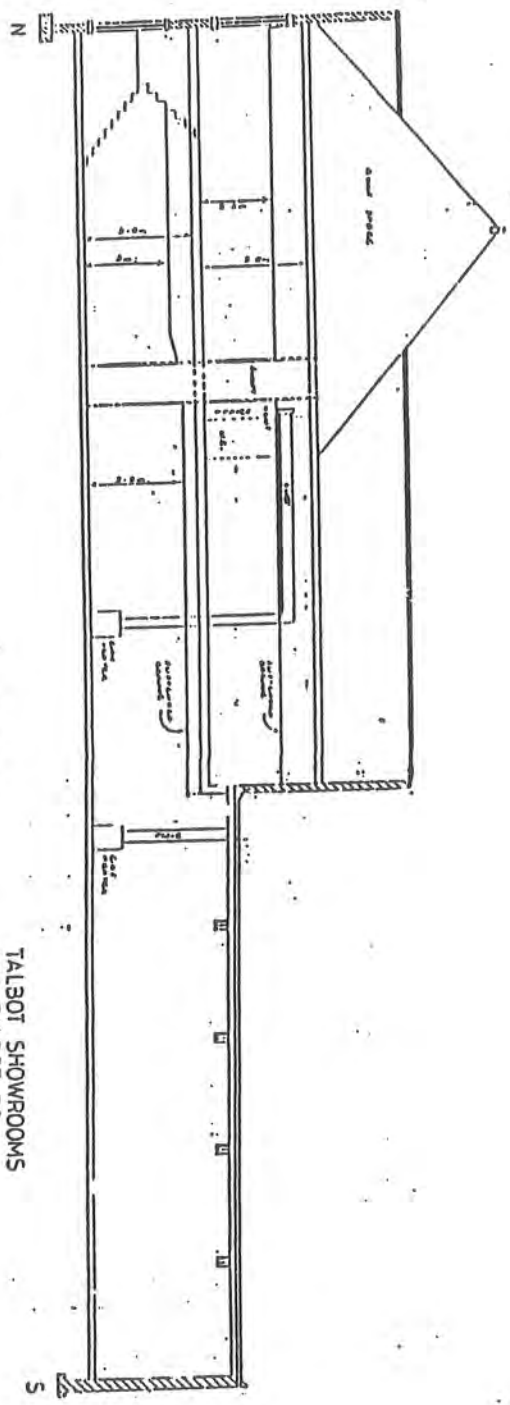
SCALE 1:100  
DRWG. NO. 3

The suspended ceilings were installed only in the two storey section of the ground and first floor showroom areas. Constructed of flame retardent panels, they were supported by means of a light metal lattice framework. The design was such that in some areas they extended below the full height of the window. The windows were recessed on the outer wall but the ceiling maintained its wall line, thus an open gap existed between the window and ceiling. This was the case with the windows facing Mather Street. (See Drawing Appendix C)
