# NATIONAL TRANSPORTATION SAFETY BOARD

**AIR FLORIDA, INC.  
BOEING 737-222, N62AF  
COLLISION WITH 14TH STREET BRIDGE,  
NEAR WASHINGTON NATIONAL AIRPORT  
WASHINGTON, D.C.  
JANUARY 13, 1982**

NTSB-AAR-82-8

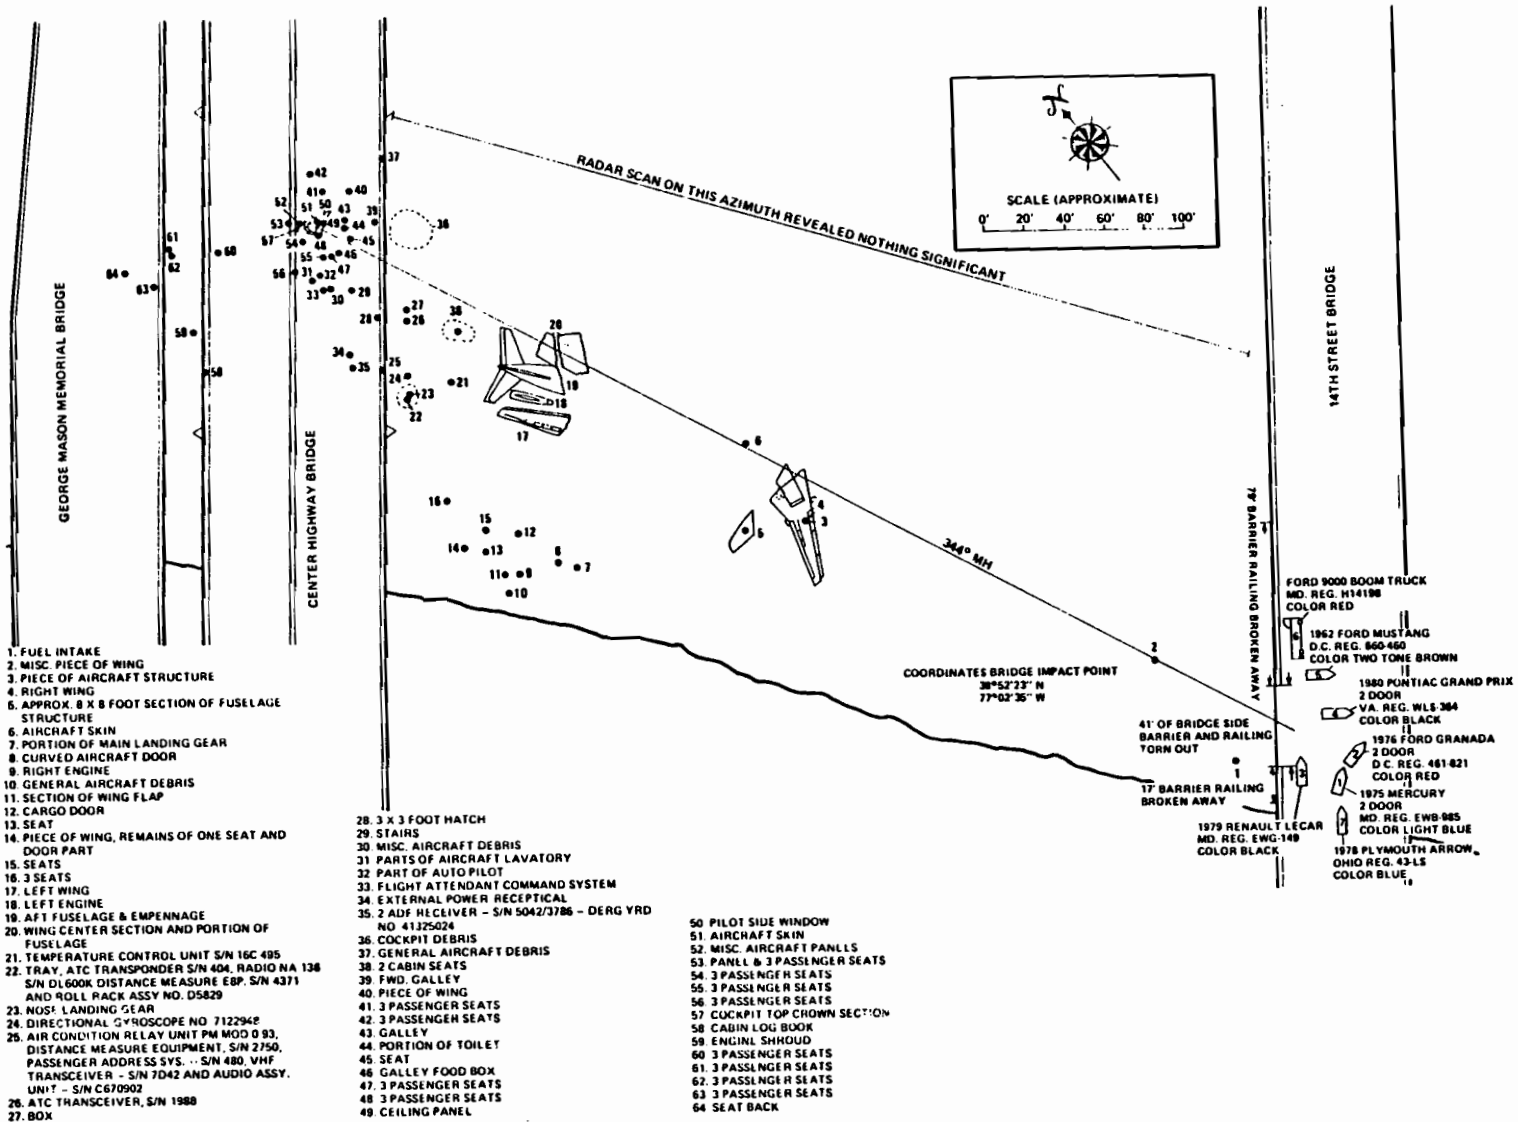
Figure 4. -- Position of Wreckage in the Water.

As the aircraft descended, the right wing was structurally damaged when it hit the boom truck, and shortly thereafter, the aircraft struck the steel barrier and railing on the west side of the 14th Street Bridge at an elevation of about 37 feet mean sea level. Fragments of the right wing remained on the bridge. The remainder of the wreckage sank in the Potomac River in about 25 to 30 feet of water. The wreckage area was confined to the south side of the river between the 14th Street Bridge and the Center Highway Bridge of the George Mason Memorial Bridge. (See figure 4.)

After initial impact, the aircraft broke into several major pieces. The fuselage broke into four major pieces which included: (1) nose section with cockpit; (2) fuselage section between nose section and wing center section; (3) fuselage-to-wing intersection; and (4) aft body structure with empennage attached. The wing structure was separated into three major pieces which included: (1) left wing outboard of the No. 1 engine, including all associated flight control surfaces; (2) wing center section, lower surface, including wing lower surface stubs between the No. 1 engine mounts and the No. 2 engine mounts; and (3) right wing outboard of the No. 2 engine with the outboard 20 feet mostly disintegrated. The left main landing gear was separated from the wing, and the right main gear remained attached except for the wheels and oleo piston. The nose landing gear and its attaching structure were separated from the nose section. Both engines and their pylon structures were separated from the wings. There was no evidence of fire on any of the recovered structure.
