# NATIONAL TRANSPORTATION SAFETY BOARD

**AIR FLORIDA, INC.  
BOEING 737-222, N62AF  
COLLISION WITH 14TH STREET BRIDGE,  
NEAR WASHINGTON NATIONAL AIRPORT  
WASHINGTON, D.C.  
JANUARY 13, 1982**

NTSB-AAR-82-8

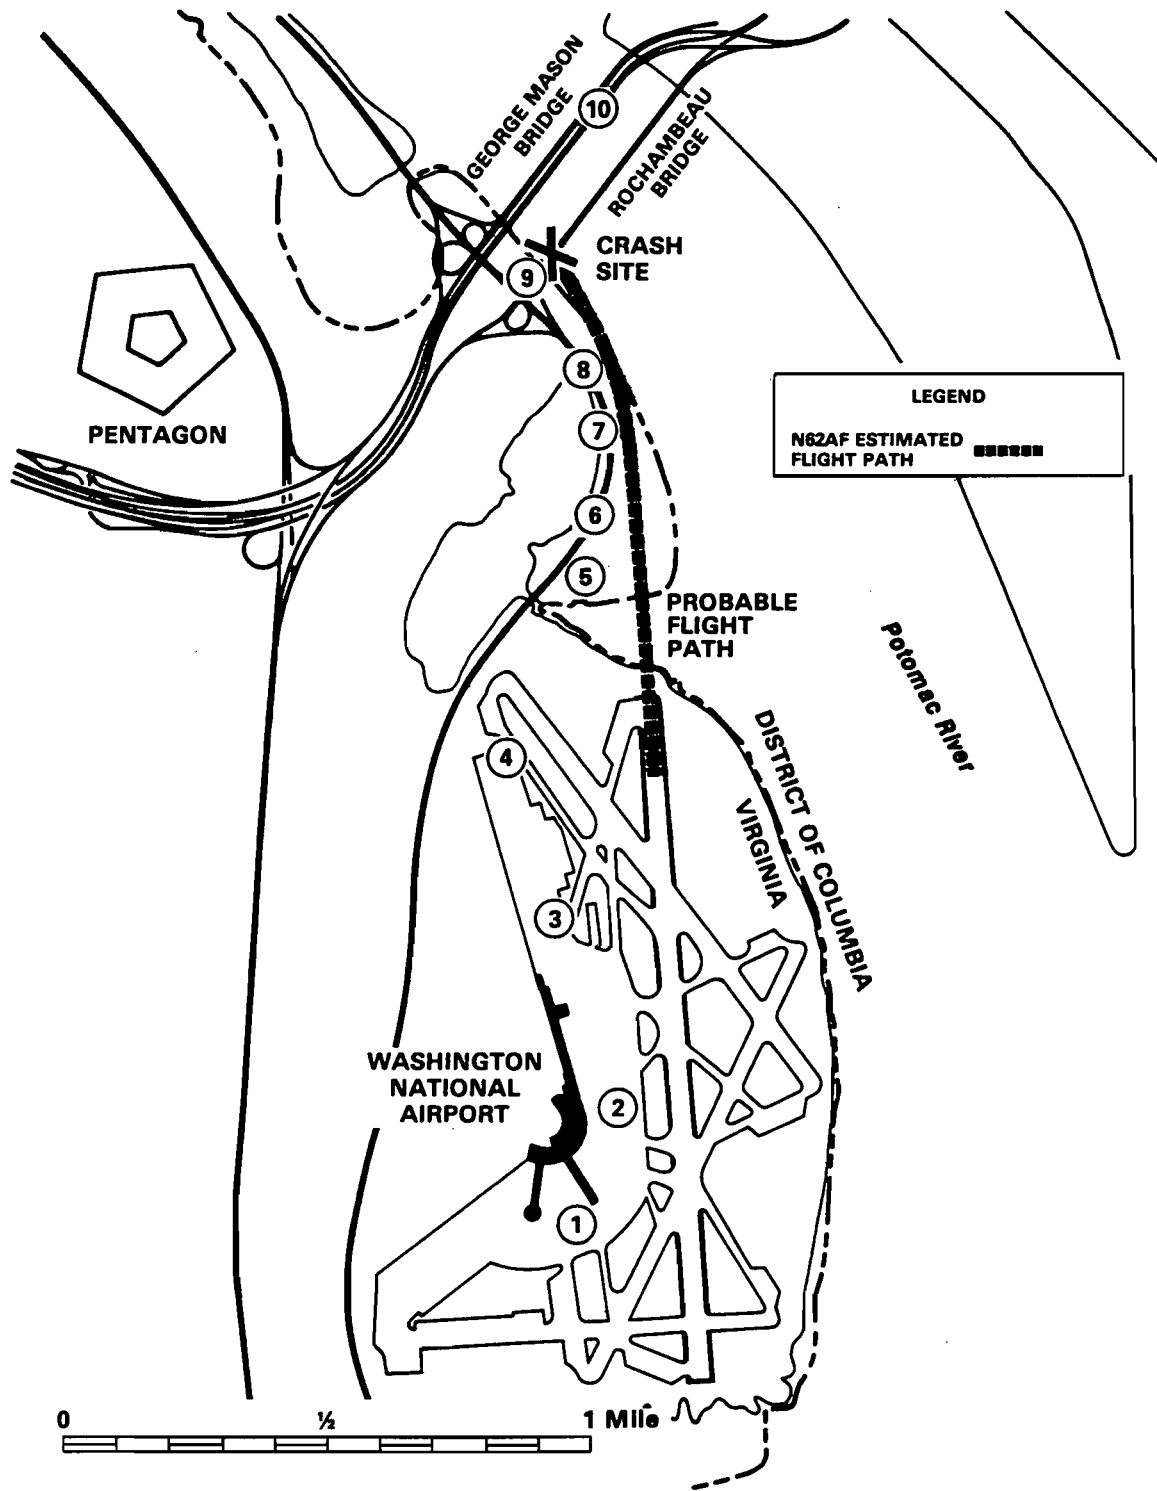
Figure 1.—Flightpath and witness locations.

Safety Board investigators interviewed more than 200 witnesses to establish the sequence of events from the start of the takeoff until impact, and more than 100 written statements were obtained. (See figure 1 for witness locations and flightpath. Numbers correlate to the locations of 10 of the witnesses interviewed.)

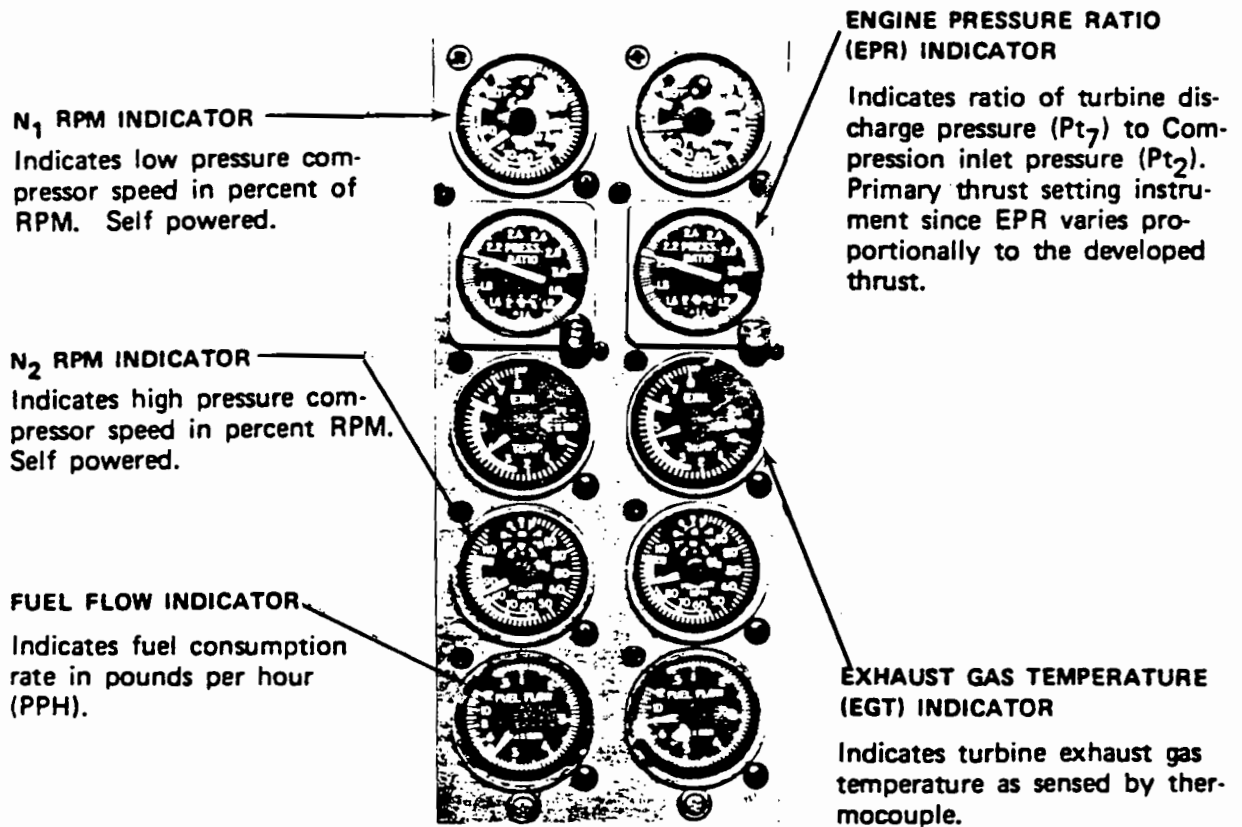
Figure 5. -- Center instrument panel functions.

The B-737's primary engine instrumentation consists of: engine pressure ratio (EPR), a direct indication of the ratio of the pressure measured at the turbine discharge pressure (Pt<sub>7</sub>) to the pressure measured at the compressor inlet (Pt<sub>2</sub>); the first stage fan or low pressure compressor speed (N<sub>1</sub>); the high pressure compressor speed (N<sub>2</sub>); the exhaust gas temperature (EGT); and the fuel flow (F/F). (See figure 5.)

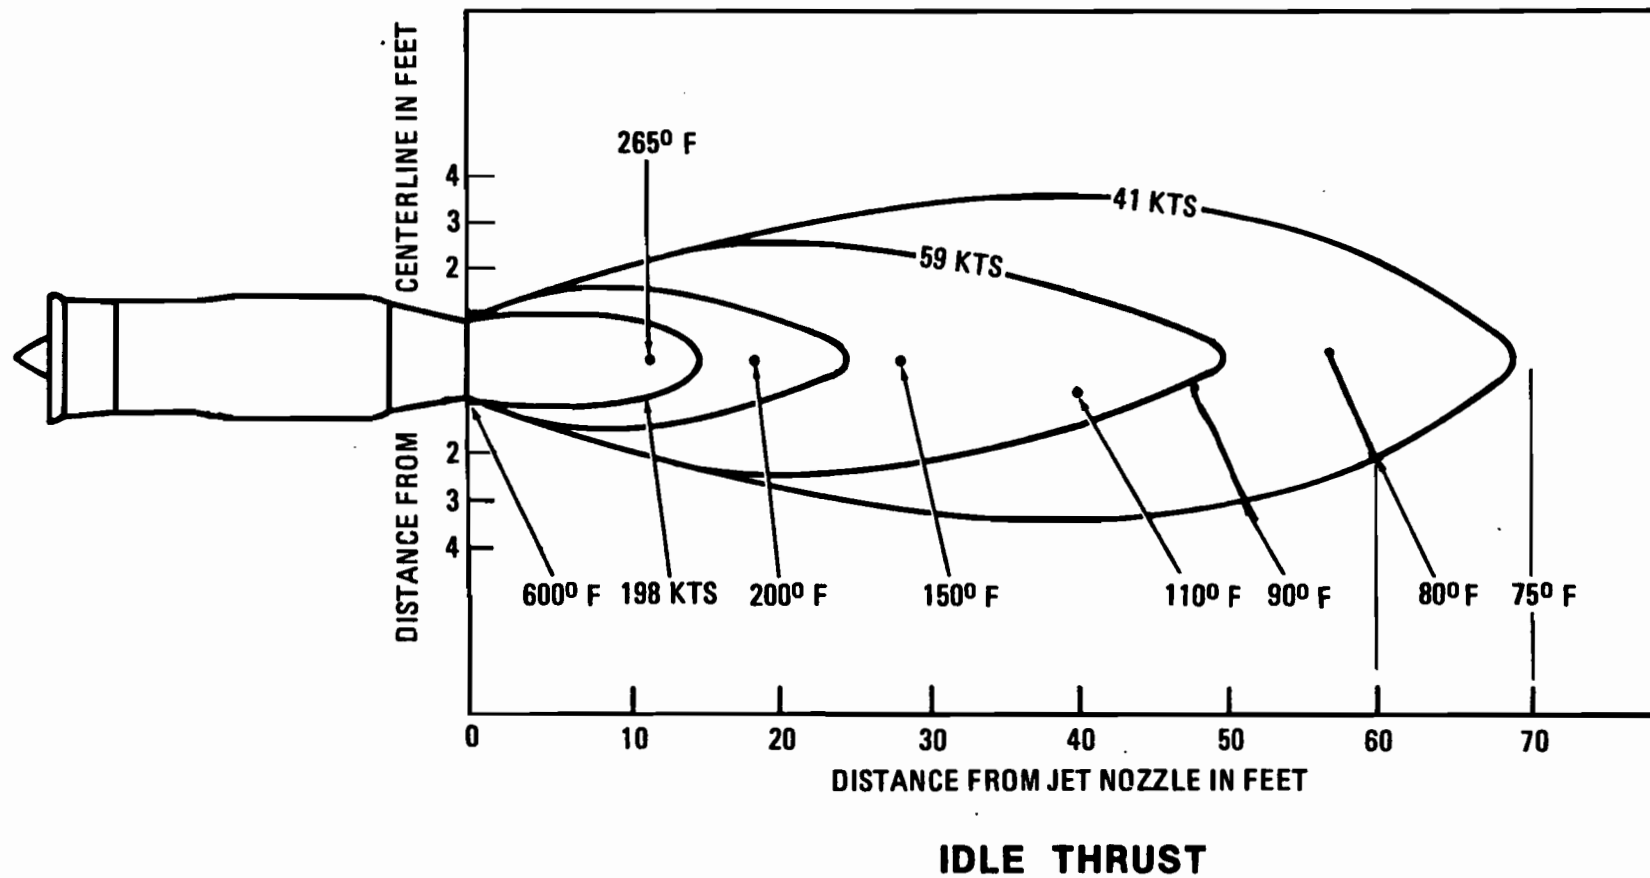
Figure 7.—JT8D turbofan exhaust gas temperatures and velocities.

Jet exhaust temperatures and velocities at given distances and power setting behind the exhaust nozzles of JT8D turbofan engines were determined to provide an indication of their effects on following aircraft. (See figure 7.)
